## Survivability Under Fire

Plumley Village Worcester Mass.

On December 27, 2006 a three-alarm fire occurred in a 16-story fully sprinklered residential building known as Plumley Village. The fire attacked the building located at 16 Laurel Street in Worcester, MA at about 4:30 AM. Plumley Village consists of a 16 building complex built in 1972. It has 15 low-rise buildings and one high-rise building.

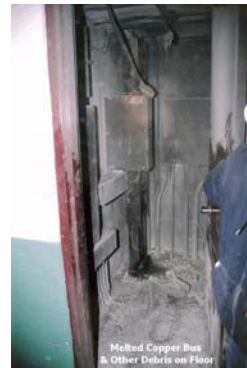
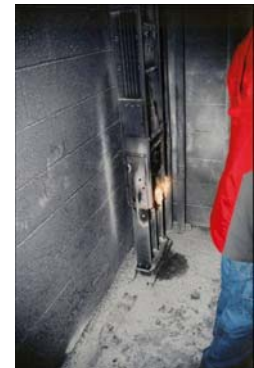
When Inspector Horgan inspected the 12<sup>th</sup> floor electrical room, he found the buss duct blown apart. Approximately 3 feet of the copper buss had presumably disintegrated from the heat. (See Figures 1 (a) and 1 (b).) All of the other wiring in the electrical closet had failed electrically. The contractor had installed the fire rated power feeder cables to the elevators in a location approximately 9-12 inches away from the buss duct that disintegrated from the heat of the fire. Although a complete automatic sprinkler system protected required areas of the building except the electrical closets, no sprinkler heads operated. The 2-hour fire rated 11<sup>th</sup> and 12<sup>th</sup> floor electrical closets contained the fire.

Figures 1(a) and 1(b): Melted copper buss and other debris on the floor

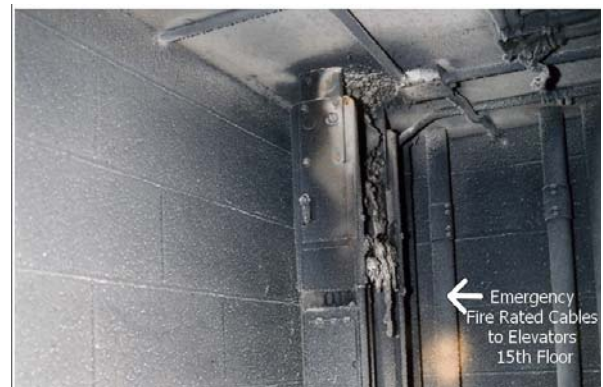
The expected performance of the fire rated cable that maintained the power to the elevator, even after all other circuits had failed, remains a unique factor of this fire. The Draka Cableteq UL 2196 qualified fire-rated cable survived when exposed to a very hot electrical fire. The location of the cable, within 9-12 inches of the melting copper buss duct ( at temperatures > 1900° F), certainly validated its anticipated operation.

Figures 2: Fire rated cable installed in 3 inch conduit next to buss duct. (Note distance of conduit from buss duct)

Craig Bonner, the building maintenance superintendent, repeatedly stated the importance of the elevator operation in the building restoration operations during the assessment and early repair stages well before a contactor replaced the existing cable. To assure continued expected performance during any future fire, the electrical contractor has now replaced the original cable with new fire rated cables, also supplied by Draka Cableteq USA.
