## Survivability Under Fire

Plumley Village Worcester Mass.

On December 27, 2006 a three-alarm fire occurred in a 16-story fully sprinklered residential building known as Plumley Village. The fire attacked the building located at 16 Laurel Street in Worcester, MA at about 4:30 AM. Plumley Village consists of a 16 building complex built in 1972. It has 15 low-rise buildings and one high-rise building.

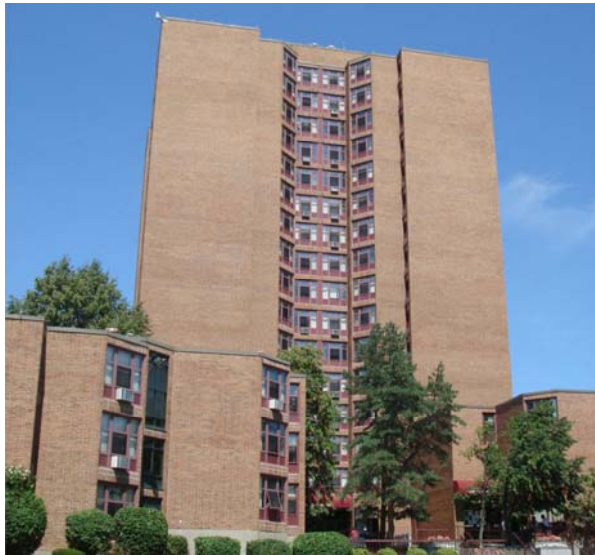
When Inspector Horgan inspected the 12<sup>th</sup> floor electrical room, he found the buss duct blown apart. Approximately 3 feet of the copper buss had presumably disintegrated from the heat. (See Figures 1 (a) and 1 (b).) All of the other wiring in the electrical closet had failed electrically. The contractor had installed the fire rated power feeder cables to the elevators in a location approximately 9-12 inches away from the buss duct that disintegrated from the heat of the fire. Although a complete automatic sprinkler system protected required areas of the building except the electrical closets, no sprinkler heads operated. The 2-hour fire rated 11<sup>th</sup> and 12<sup>th</sup> floor electrical closets contained the fire.

The expected performance of the fire rated cable that maintained the power to the elevator, even after all other circuits had failed, remains a unique factor of this fire. The Draka Cableteq UL 2196 qualified fire-rated cable survived when exposed to a very hot electrical fire. The location of the cable, within 9-12 inches of the melting copper buss duct ( at temperatures > 1900° F), certainly validated its anticipated operation.

Craig Bonner, the building maintenance superintendent, repeatedly stated the importance of the elevator operation in the building restoration operations during the assessment and early repair stages well before a contactor replaced the existing cable. To assure continued expected performance during any future fire, the electrical contractor has now replaced the original cable with new fire rated cables, also supplied by Draka Cableteq USA.
